## Left Ventricle Pseudoaneurysm After Mitral Valve Replacement: Case Report and Literature Update

### Introduction

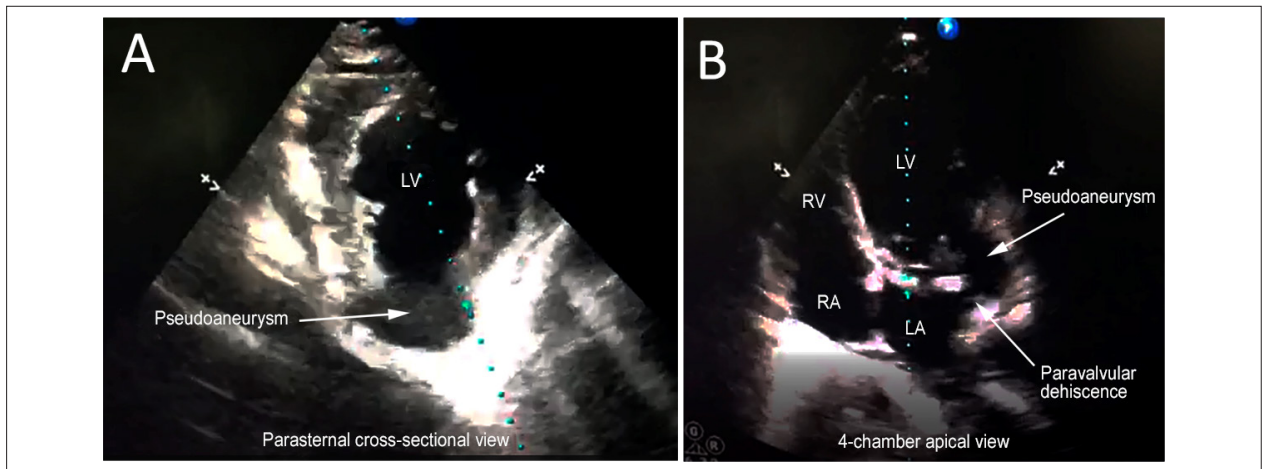
**Figure 1** – Transthoracic echocardiogram showing pseudoaneurysm in the left ventricular (LV) inferolateral wall in the parasternal transverse (A) and apical four-chamber (B) views. RV: right ventricle; LA: left atrium; RA: right atrium.

ruled out after serial evaluation of troponin and creatine kinase-MB (CK-MB). Transthoracic echocardiography (TTE) was also performed. Its main findings were pseudoaneurysm (Figure 1), severe paraprosthetic reflux (Figure 2) and rupture of chordae (Videos 1 and 2).

Pseudoaneurysm at the base of the LV inferolateral wall was also suspected. Due to the clinical picture and the echocardiographic findings, surgical treatment was chosen, which confirmed the presence of subvalvular LVPA. Plication of the pseudoaneurysm was performed with Prolene®3.0 wire, followed by placement of a new bioprosthesis #29. Postoperatively, the patient progressed clinically well and was discharged from hospital with administration of diuretics, beta-blockers, angiotensin-converting enzyme inhibitor and anticoagulation after 14 days in hospital. Postoperative TTE showed well-positioned and normal-functioning bioprosthesis, with no evidence of leaking.

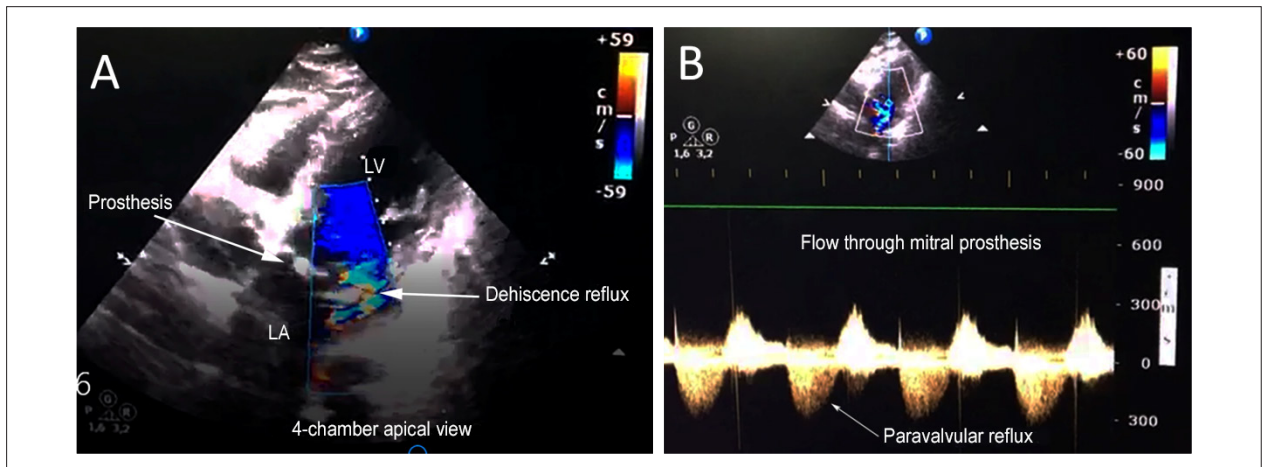
**Figure 2** – Transthoracic echocardiogram showing mitral prosthesis, paravalvular dehiscence and severe paraprosthetic reflux (A and B). LV: left ventricle; LA: left atrium.

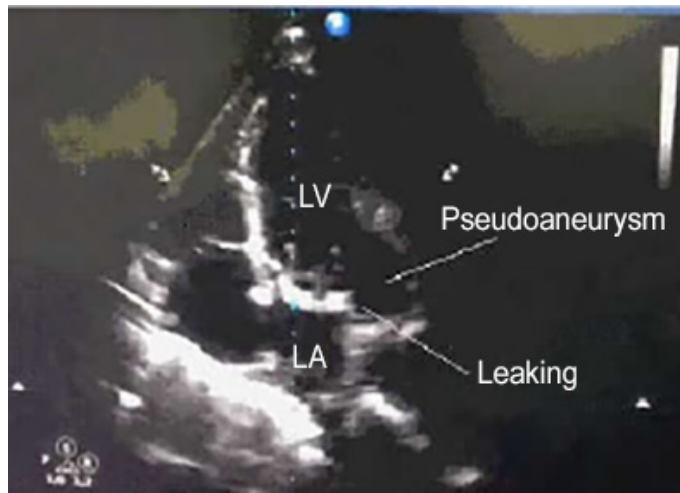
**Video 1** – Apical 4-chamber view showing mitral prosthesis, pseudoaneurysm in the left ventricular inferolateral wall, and flow through it. Watch the videos here: [http://departamentos.cardiol.br/dic/publicacoes/revistadic/2018/v31\\_3/video\\_v31\\_3\\_212\\_ingles.asp](http://departamentos.cardiol.br/dic/publicacoes/revistadic/2018/v31_3/video_v31_3_212_ingles.asp)

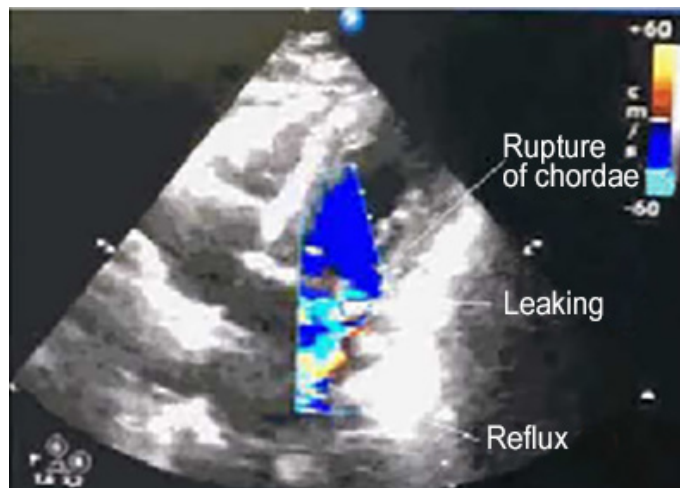
**Video 2** – Apical 4-chamber view showing mitral prosthesis, pseudoaneurysm in the left ventricular inferolateral wall, and flow through it. Watch the videos here: [http://departamentos.cardiol.br/dic/publicacoes/revistadic/2018/v31\\_3/video\\_v31\\_3\\_212\\_ingles.asp](http://departamentos.cardiol.br/dic/publicacoes/revistadic/2018/v31_3/video_v31_3_212_ingles.asp)
